FACILITY COMPLIANCE INSPECTION REPORT

Division of Waste Management

Solid Waste Section

David Brantley & Sons, Inc.
37 Pine Ridge Road
Zebulon, NC 27597

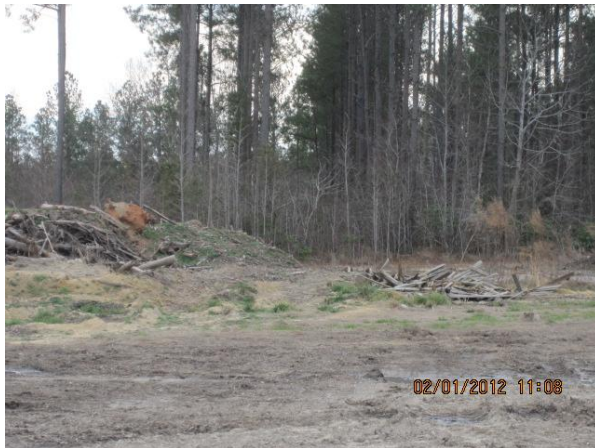
Small pile of lumber (to the right side) to be removed

10. There were two or three small areas of ponding water. The site must be kept graded to prevent any ponding of water.
11. There was a pile of boards to the back of the site that needs to be removed.

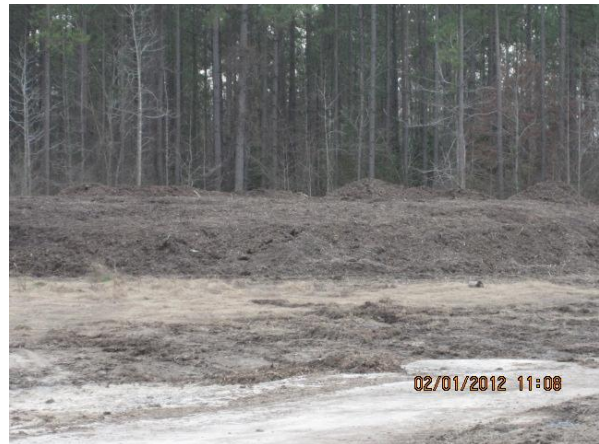
Finished product to the rear of the site

5. The area being used to compost and store product is under two acres. The finished 'product' is being kept at the site for several years prior to its future use as a Class A product. There is a pile of sand and soil on the site which is mixed in with the final product.

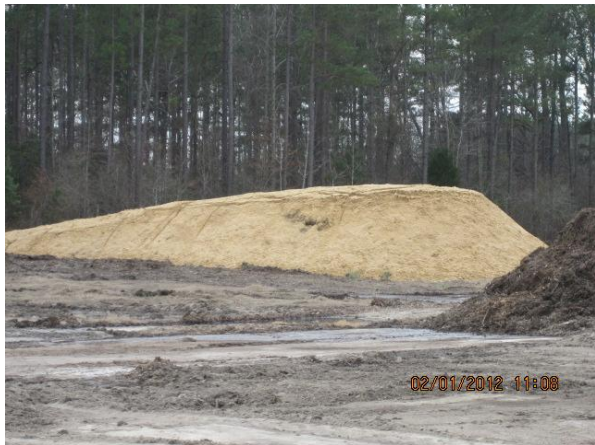
Pile of sand and soil to be mixed with final product

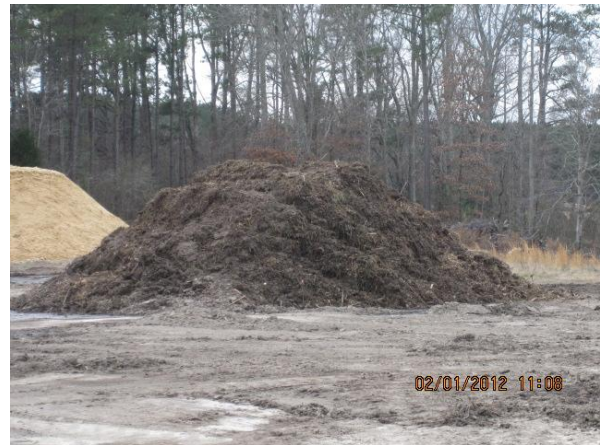
Septage and/or grease mixed with bulking material, on concrete dewatering another 24 hours

6. The compost method being used is the windrow method. The windrows are 5-7 feet high, approximately 40 feet in length and approximated 9 feet wide.
7. The dewatered sludge mixed with the bulking material is brought out to the area where the windrows are formed, on a concrete access path and stored on the concrete for another 24 hours or so to allow further dewatering, prior to being windrowed.

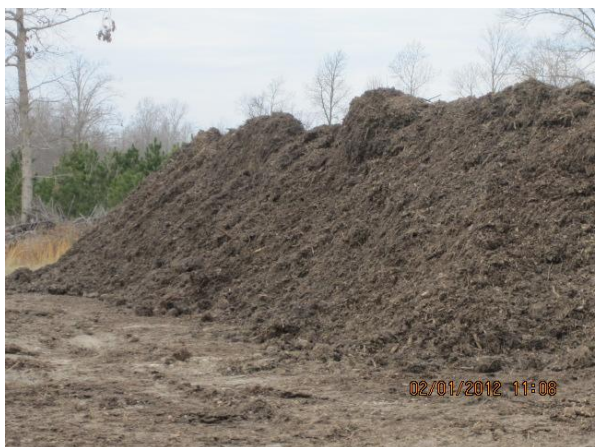
Windrowed material

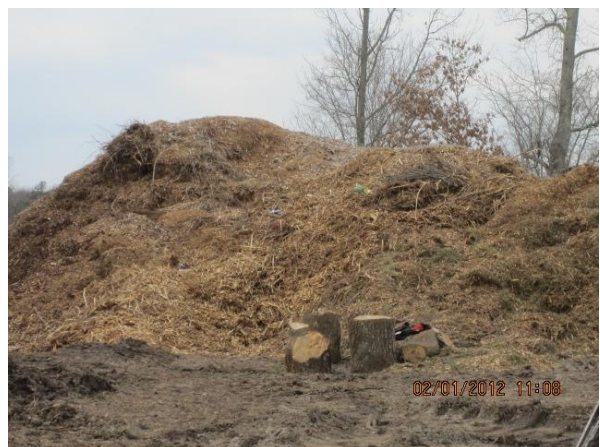
Bulking material

2. The materials to be composted include dewatered septage and/or grease with a bulking material. The bulking material being used at this time is wood chips supplied by Asplundh.
